Evaluation of Environmental Controls at a Homeless Shelter Associated with a Tuberculosis Outbreak – Texas

Health Hazard
Evaluation Program

Report No. 2013-0145-3209
May 2014

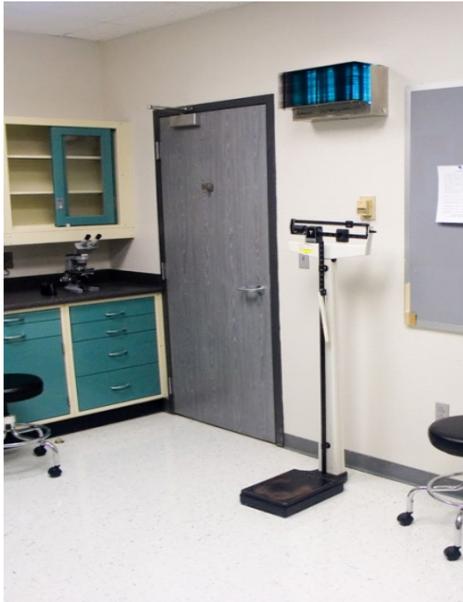
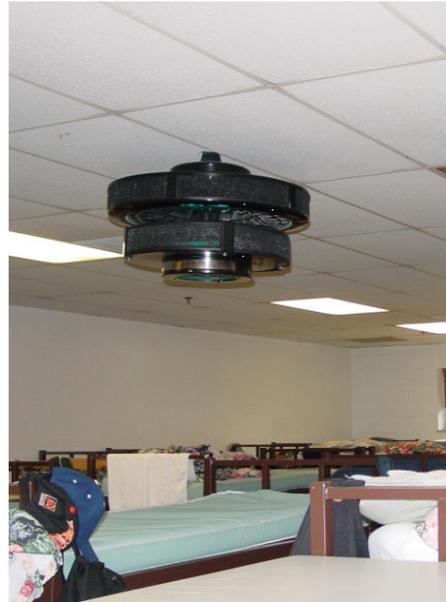
Figure 1. Typical upper-air UVGI installations: Left–Wall-mounted fixture with louvers installed in a health clinic; Right–Ceiling-mounted fixture with an internal fan installed in a homeless shelter.

We recommend consulting with a qualified UVGI fixture manufacturer or system engineer, familiar with the NIOSH upper-room UVGI guidelines, to design and install an upper-air UVGI system in the pavilion sleeping area. The 17-foot ceiling height in that space provides an excellent opportunity to utilize a variety of commercially-available fixtures to create a large irradiance zone in the upper portion of the room. The ability to mount the fixtures at higher heights will also help prevent the fixtures from being tampered with. The two large ceiling fans will also provide air mixing within the entire space that is critical for optimum upper-air UVGI system performance. Representatives from the shelter also reported that an upper-room UVGI system is currently being installed inside the large reception area in the welcome building. Another area where upper-air UVGI should be considered is the main large circular
